Allision of Hong Kong-Registered Containership M/V *Cosco Busan*  
with the Delta Tower of the San Francisco–Oakland Bay Bridge  
San Francisco, California  
November 7, 2007

NTSB/MAR-09/01  
PB2009-916401

# **Marine Accident Report**

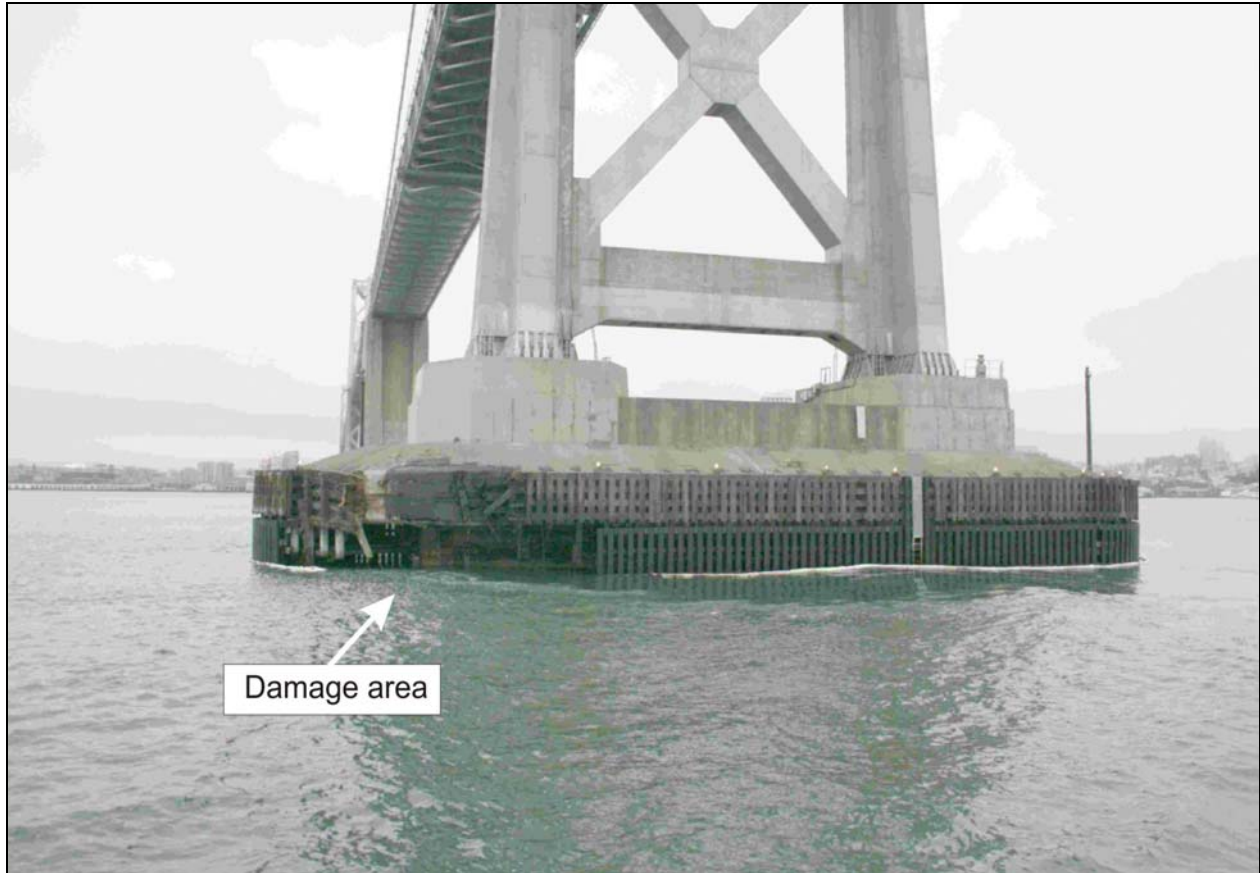
engineer, and a state transportation engineer inspected the pier. They found that about 100 feet of the fendering and skirt at the southeast corner of the Delta pier had been damaged (see figures 5 and 6), but they found no damage to the pier itself or to any other part of the bridge structure.

**Figure 5.** Damaged fendering system at the base of the Bay Bridge Delta tower.

Cost to repair the damage was \$1.5 million. By 0950, Caltrans engineers had completed their inspection and found no damage that would compromise the structural integrity of the bridge.

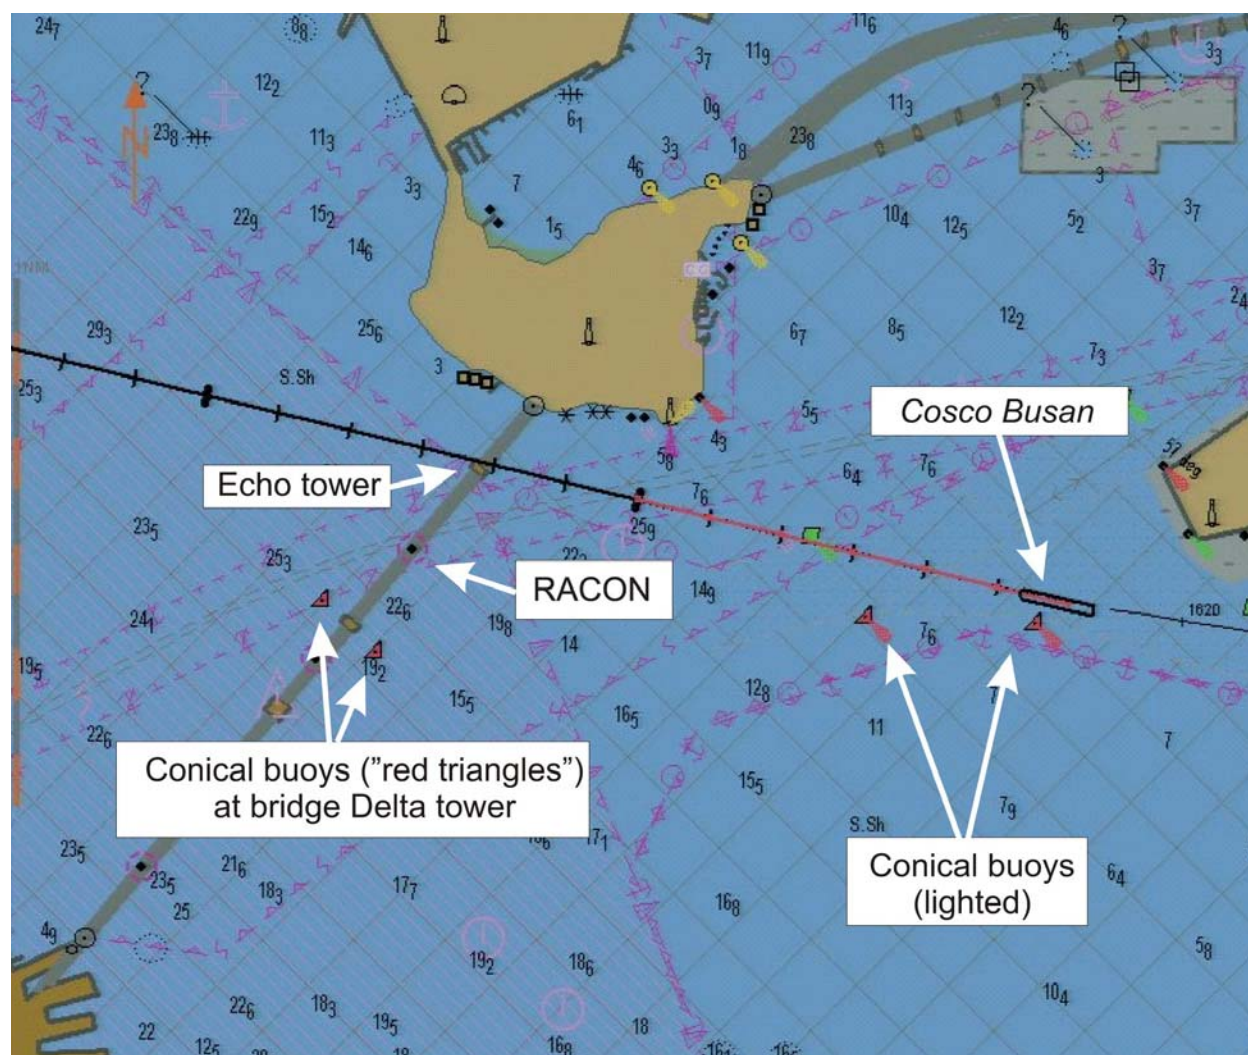
**Figure 8.** The Bay Bridge as displayed on the electronic chart on board the *Cosco Busan*. The chart display is from 0821:51, the approximate time the pilot questioned the ship’s master about the meaning of the red triangles at the bridge.
