Allision of Hong Kong-Registered Containership M/V *Cosco Busan*  
with the Delta Tower of the San Francisco–Oakland Bay Bridge  
San Francisco, California  
November 7, 2007

NTSB/MAR-09/01  
PB2009-916401

# **Marine Accident Report**

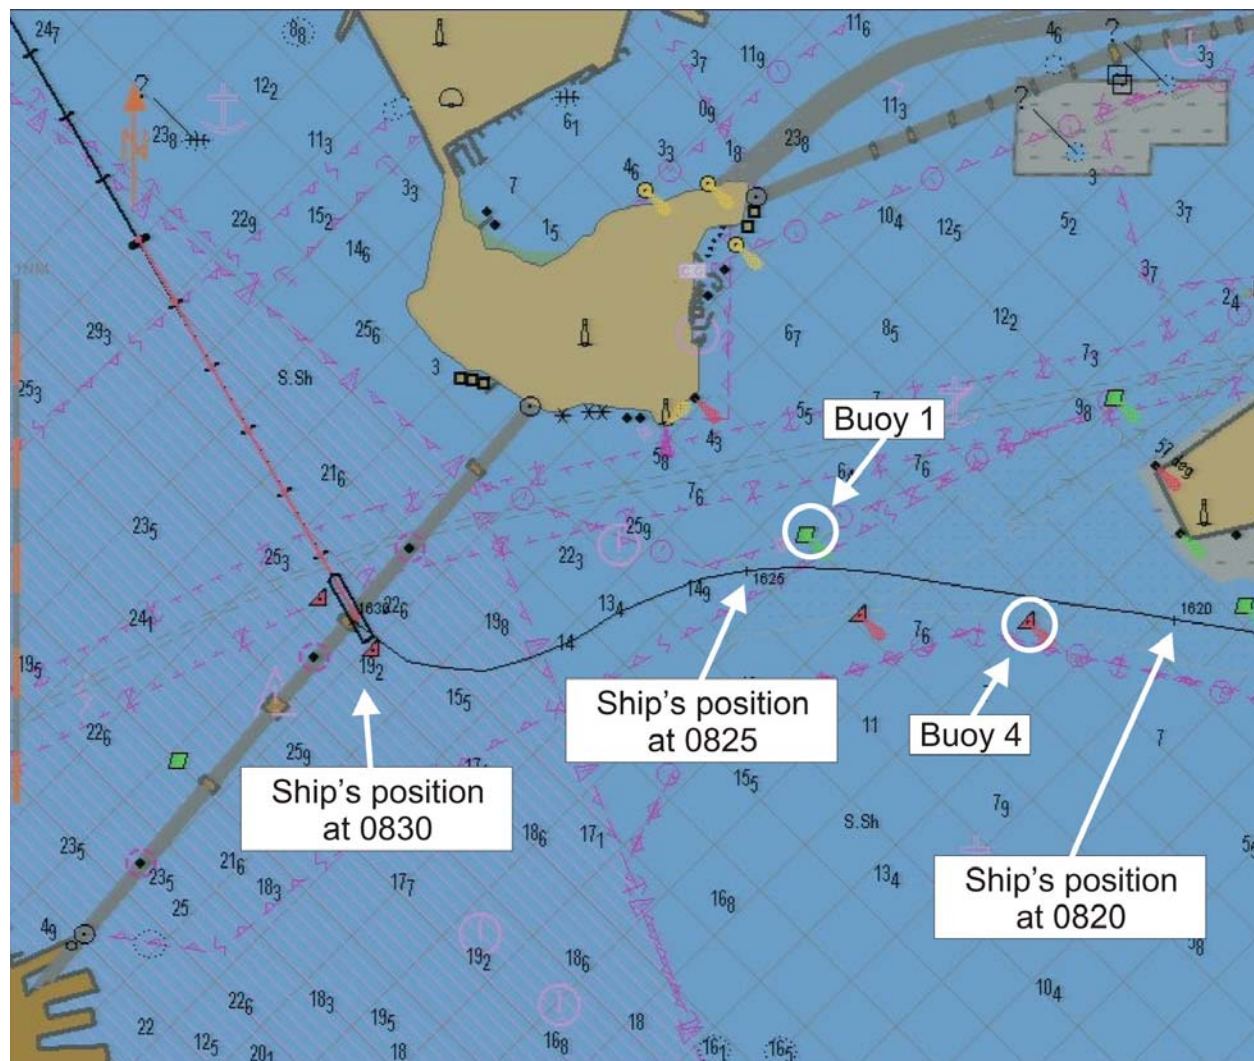
**Figure 9.** Electronic chart from the *Cosco Busan* showing the vessel's track from the entrance channel to the bridge during the accident voyage. The ship's position was marked on the chart at 5-minute intervals.

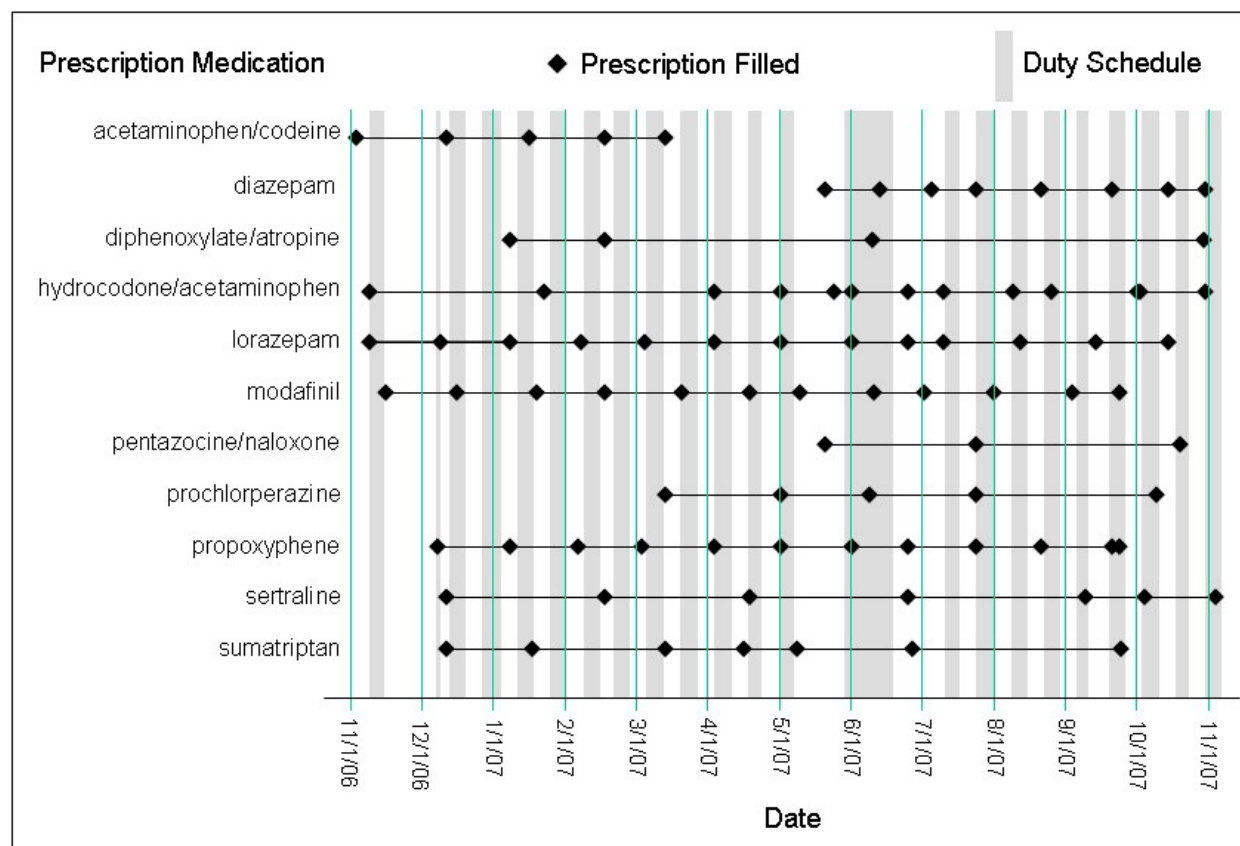
**Figure 12.** Graphical display of the *Cosco Busan* pilot's prescription history and duty schedule for the year preceding the allision. Each diamond denotes the filling of a prescription for the medication indicated.
